Moosic Lakes Club  
25 Beach House Road  
Jefferson, PA 18436  
Attn: John Kubash, President

**RE: Existing Culvert Analysis**

On Monday May 12, 2014, our office performed the requested analysis of the existing culvert along the "S" Curve of Old Lake Road just north of the intersection with Sunset Drive within the Moosic Lakes development.

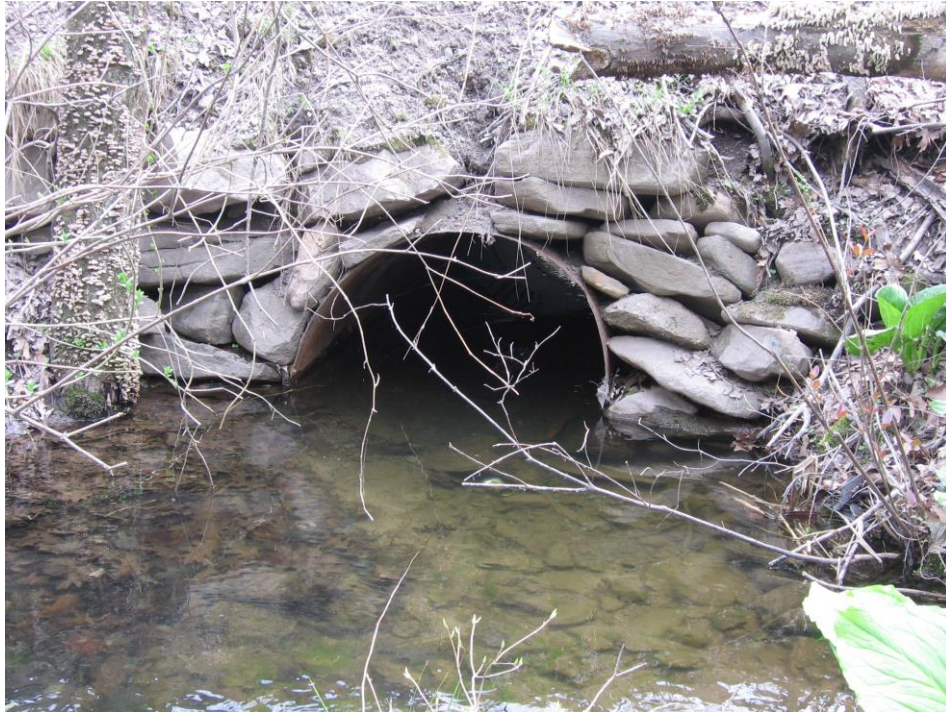
**Upstream end of existing Culvert  
(note deformed pipe opening)**

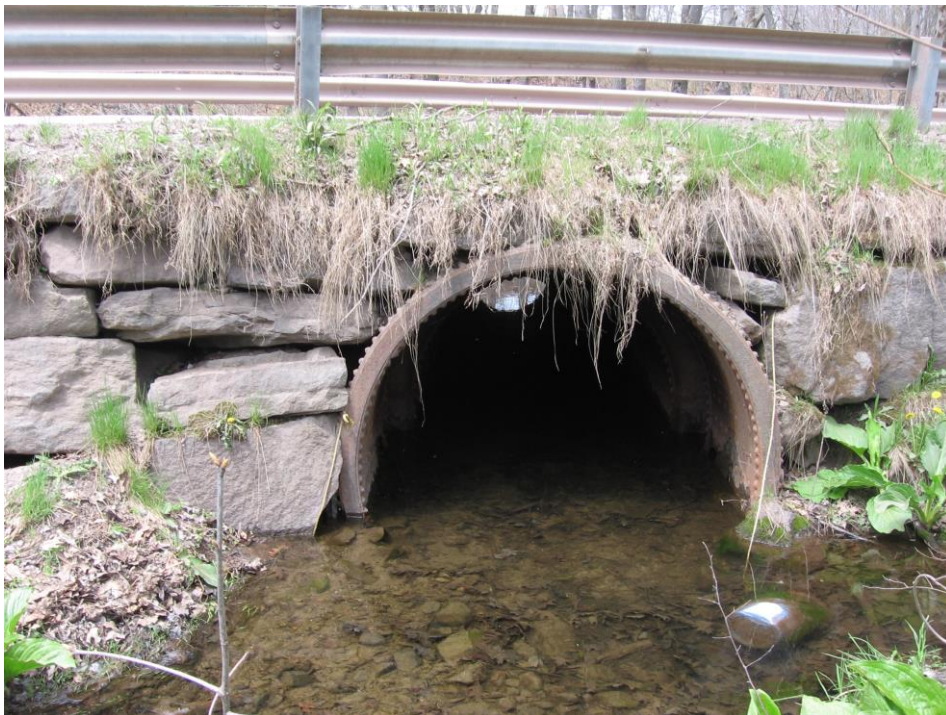
**Downstream end of existing Culvert**

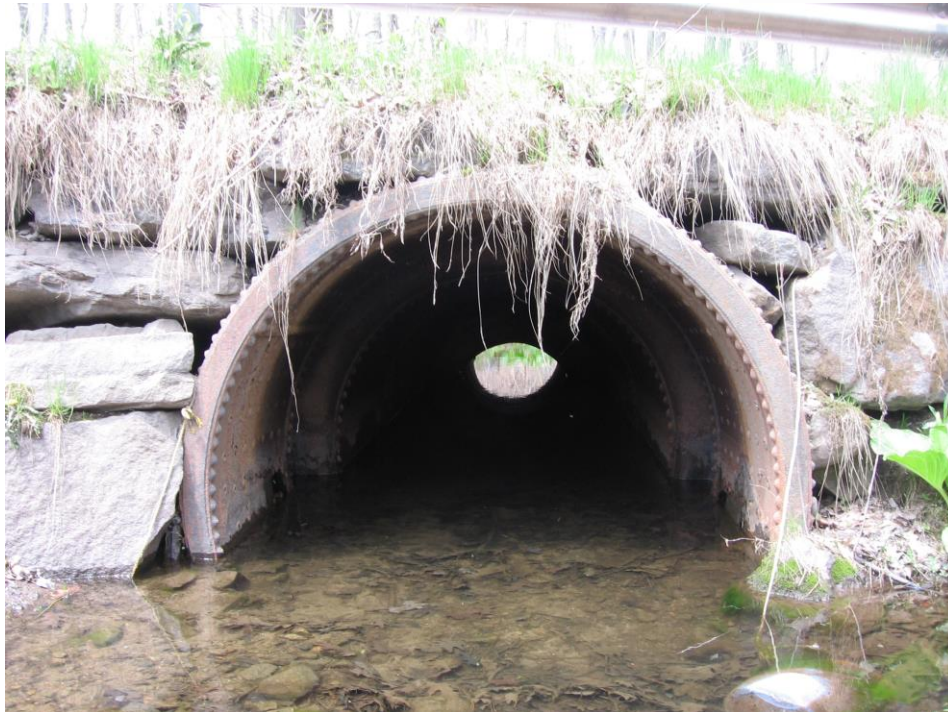
The existing culvert is approximately 29 feet long and is a combination of riveted steel plate and rolled steel pipe. The diameter of the existing culvert changes from the upstream end of 42" rolled steel pipe for approximately 15 feet, changes to a 60" riveted steel plate culvert for the next 9 feet and changes again to a 70" riveted steel plate culvert for the remaining 5 feet. As can be seen in the attached photographs, the bottom of the steel culvert has eroded at the downstream end and no pipe is evident at the bottom of the upstream end of the culvert. The rolled steel portion of the upstream culvert has deformed over time. The streambed has silted in what remains of the invert of the existing culvert and the pipe currently has no slope which restricts the capacity of the existing pipe. The existing culvert acts as the downstream release point of Moosic Lake into the West Branch of Wallenpaupack Creek.

**Note Pipe Size Change Under Roadway**

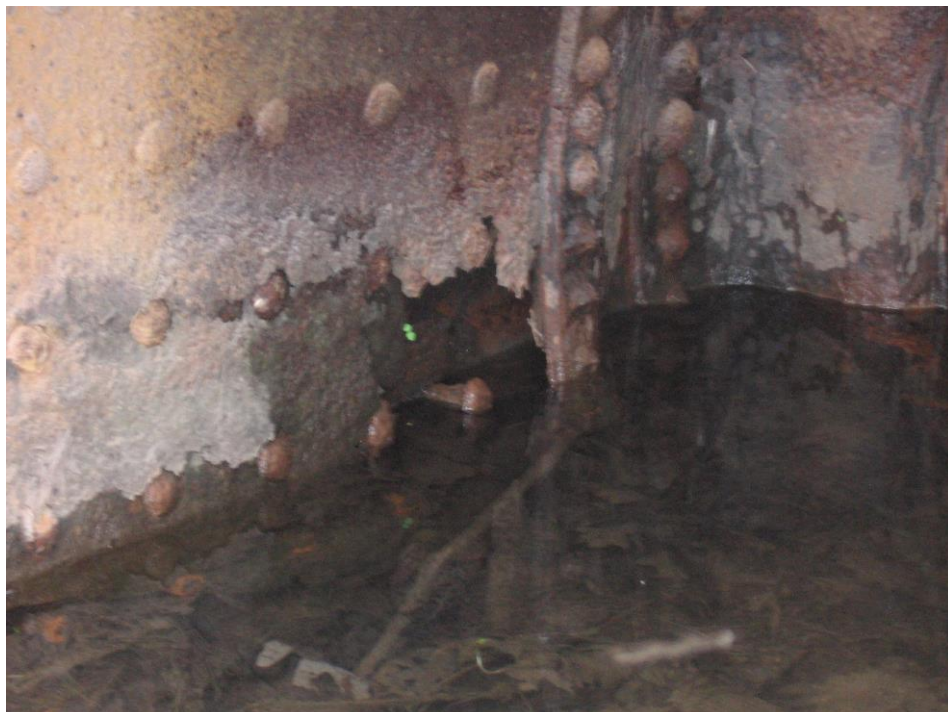
Structural failure of the top of the pipe is not currently evident, however continuing failure of the bottom of the pipe has the ability to eventually compromise the roadway and access to the Moosic Lakes Development. The road surface has been overlaid with gravel material numerous times in the past and the height of the guide rail along both sides of the road near the culvert is well below the standard height for guiderail (22" existing height vs. 27" design height).

**Deterioration of Bottom of Existing culvert**

We hope the above information is satisfactory for your current needs. Our office can provide you with the technical assistance to design and permit a replacement of the existing culvert, if required.

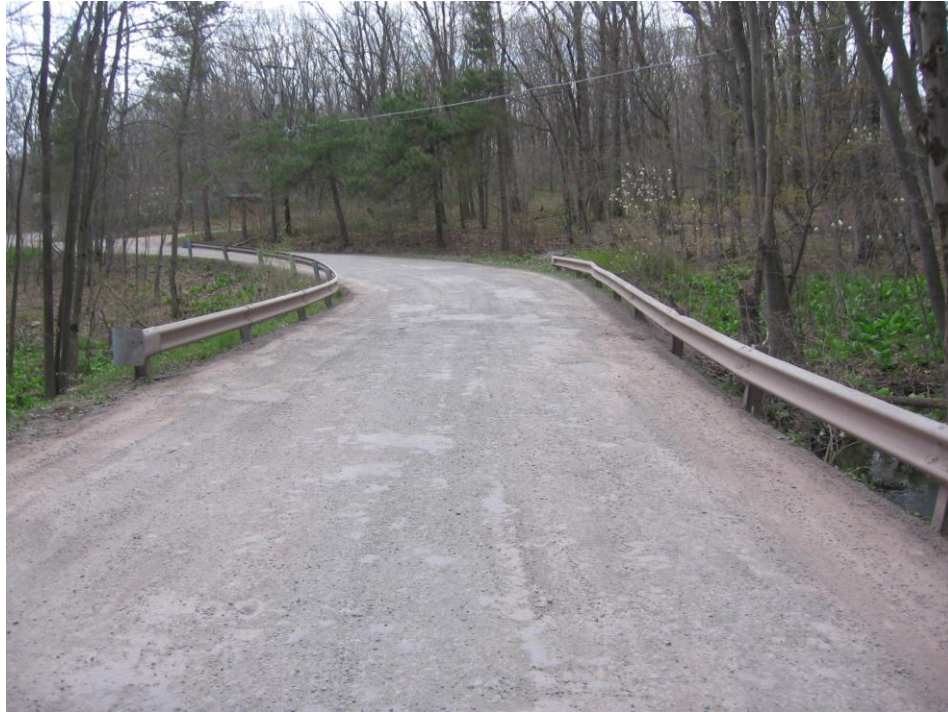
**Existing Roadway over Culvert**
